GREATER GEORGIA BASIN  
**STEELHEAD** Recovery Plan  
[www.SteelheadRecoveryPlan.ca](http://www.SteelheadRecoveryPlan.ca)

Date: January 9, 2007

**Memo: Post-Flood (Nov. 2006) Inspection of Seymour River Habitat Structures**

Prepared for: Greg Wilson, Ministry of Environment, Lower Mainland Regional Office

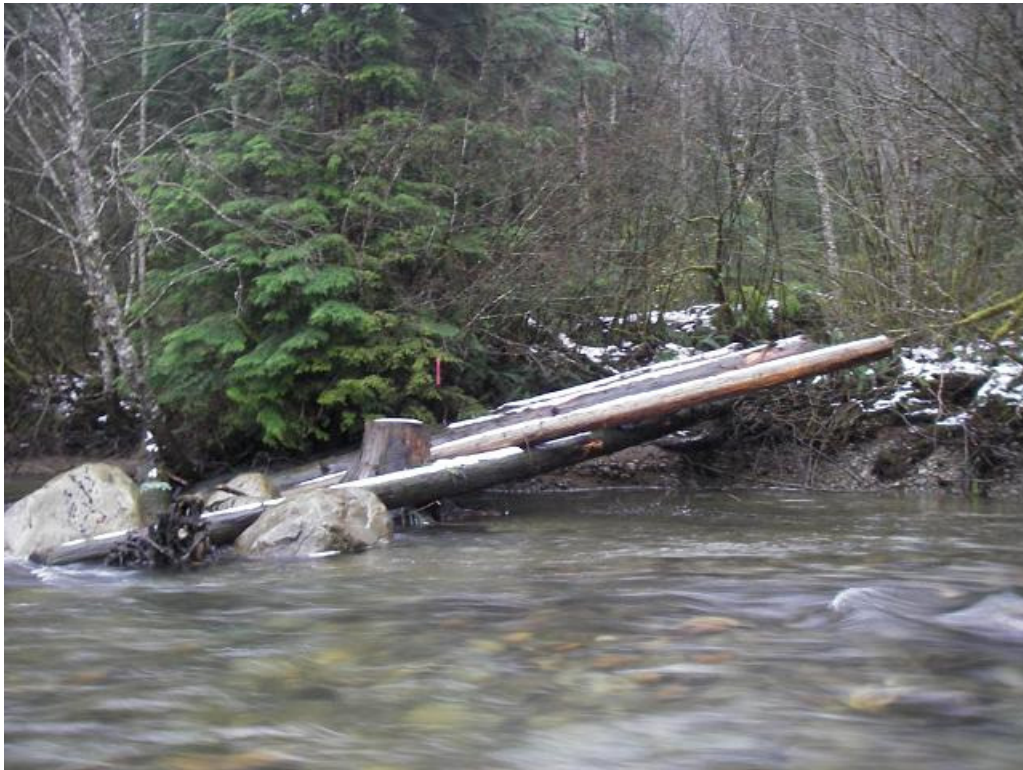
- Upstream of the Spur 6 access point, flood flows eroded a small portion of the bank at the downstream end of a triangulated structure (Figure 1). While immediate action is not warranted (safety and anchoring cables were not observed 'tight'), the structure will continue to be monitored for additional erosion-related issues.
- Downstream of the Spur 6 access point, flood-level water was able to get behind the triangulated structure and erode a portion of the bank (Figure 2). Some minor

**Figure 1: LWD structure upstream of Spur 6 access point; high river levels eroded a portion of the bank behind the downstream primary log.**

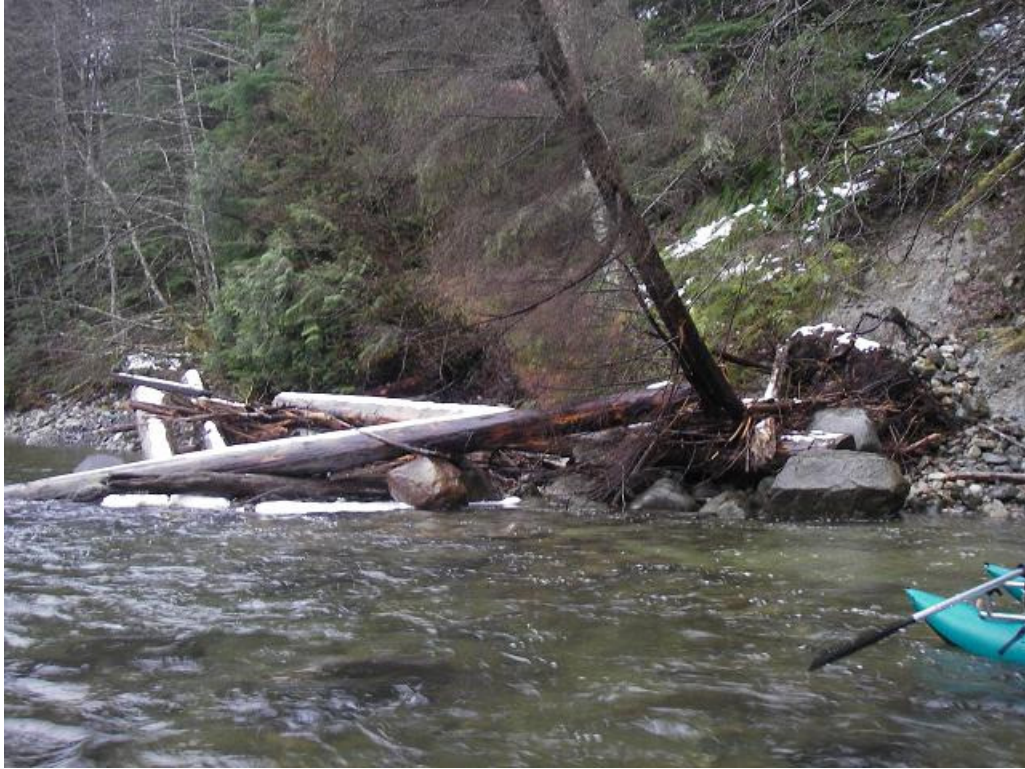
shifting of the structure occurred (cables observed 'tight'), but the structure is fully functional and has not migrated from its original position. While there is no immediate threat of the structure failing, or risk to navigation, monitoring will continue and plans are underway to perform corrective action.

**Figure 2: LWD structure downstream of the Spur 6 access point showing some of the bank erosion that occurred during the early November flood event (note: tree slide occurred several years ago).**

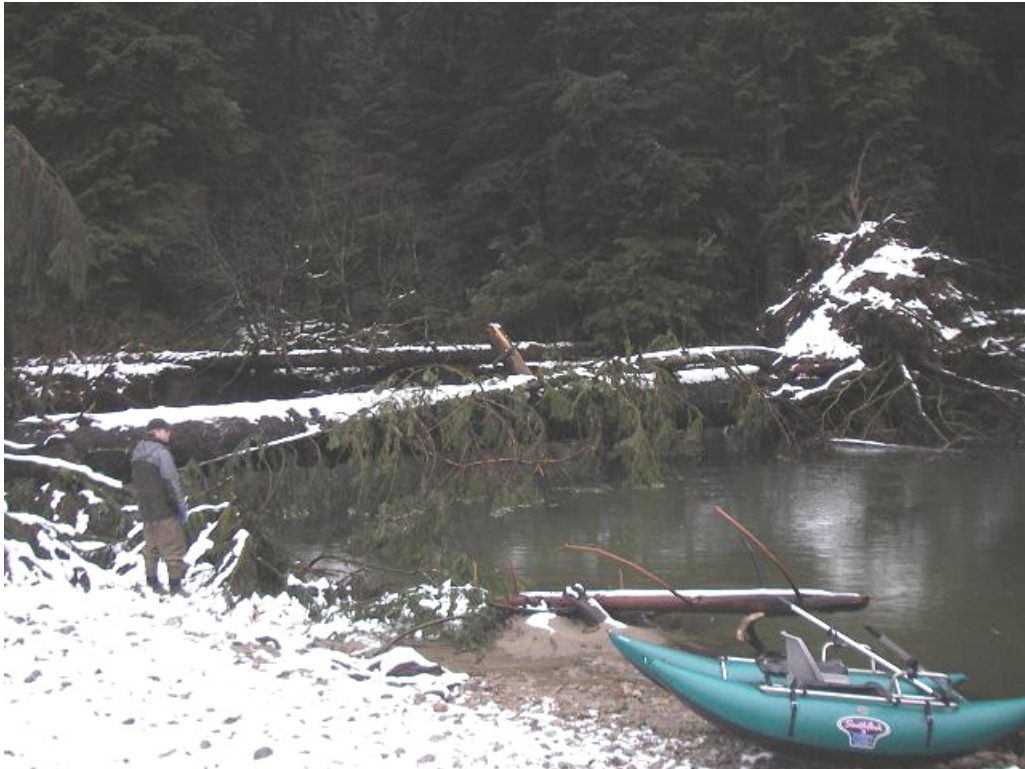
In addition to structure inspections on Dec. 20<sup>th</sup>, natural wood recruitment was observed in a number of locations, most notably near the Spur 7 access road. A large fir tree (Figure 3) fully spans the river channel and should be avoided by anyone paddling this reach of the river.

**Figure 3: Large fir brought down by bank erosion (probably combined with recent high winds) that is fully spanning the channel width immediately adjacent to the Spur 7 access road.**
