Seymour River Water Main & Boulder Installations Post-Construction Report

Recreational Canoeing Association of BC

September 23, 2006

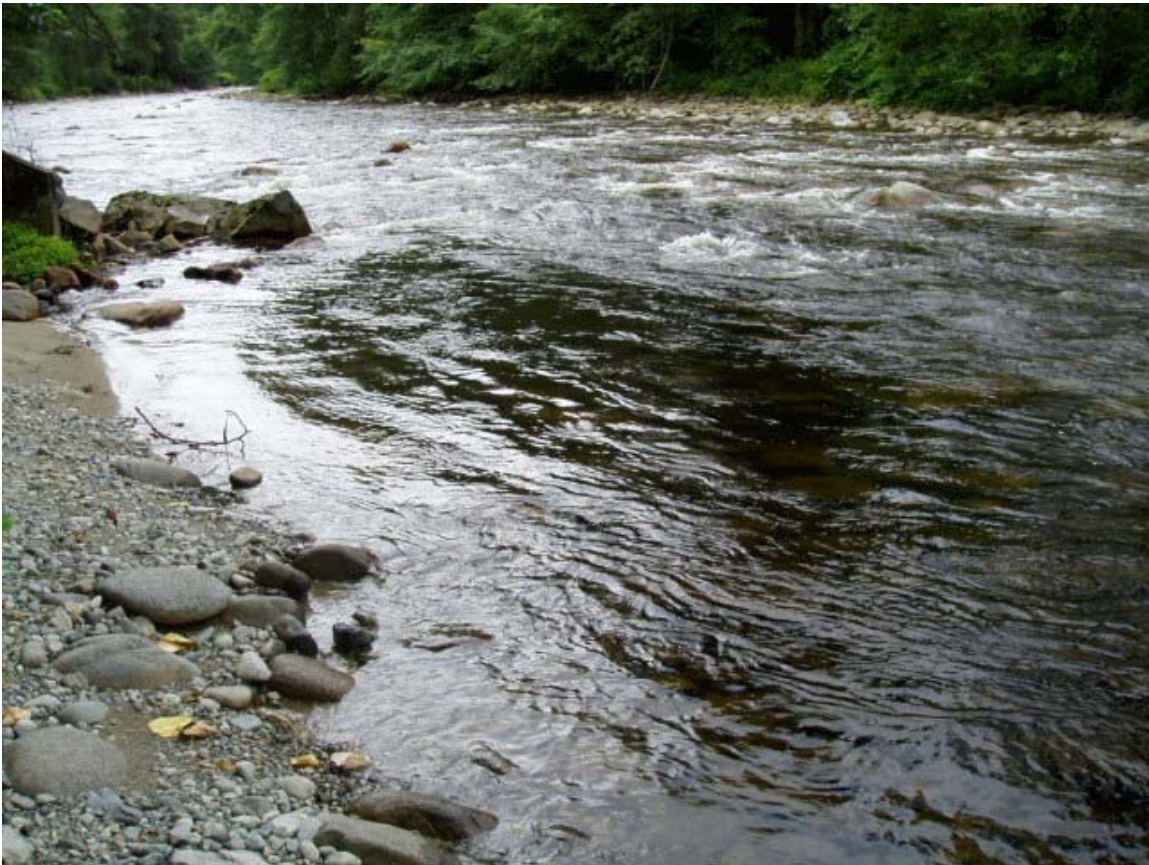
Photo 1- the old riverbed in 2005, upstream of water main.

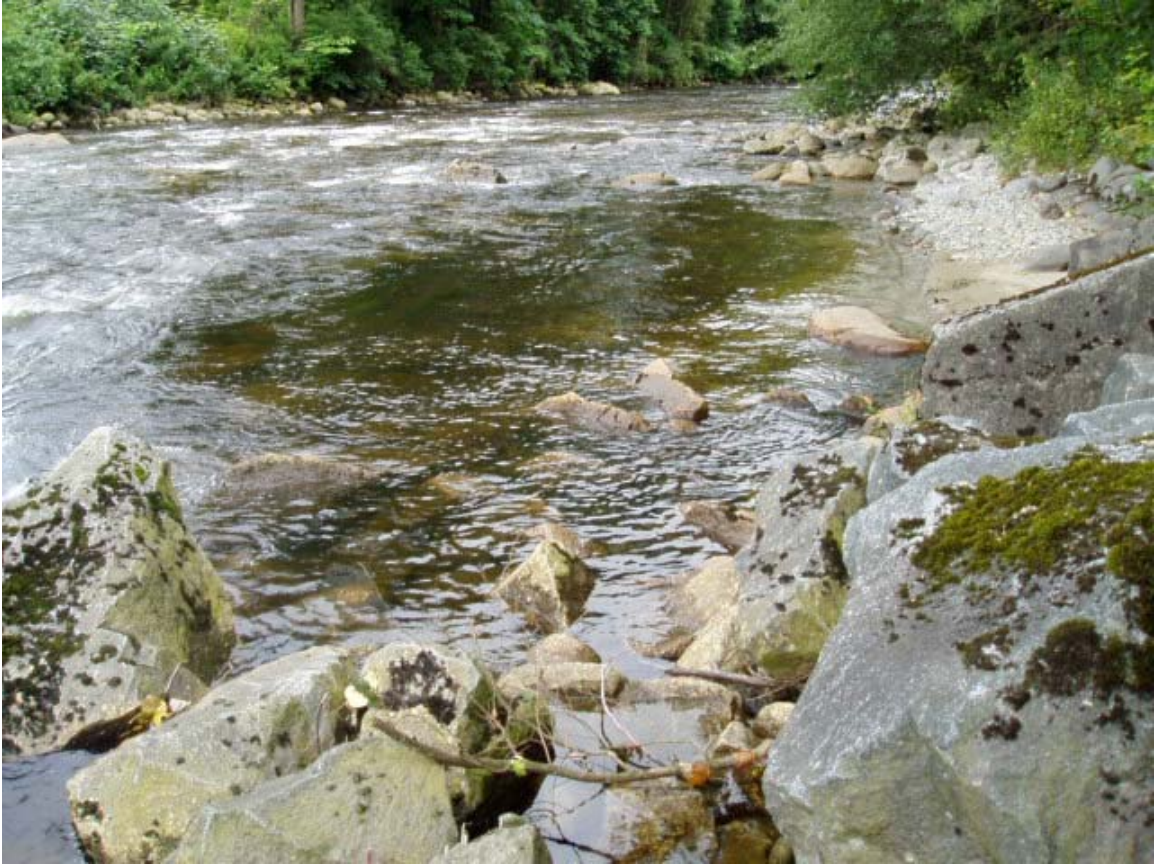
Photo 2 – The old riverbed in 2005, downstream of water main

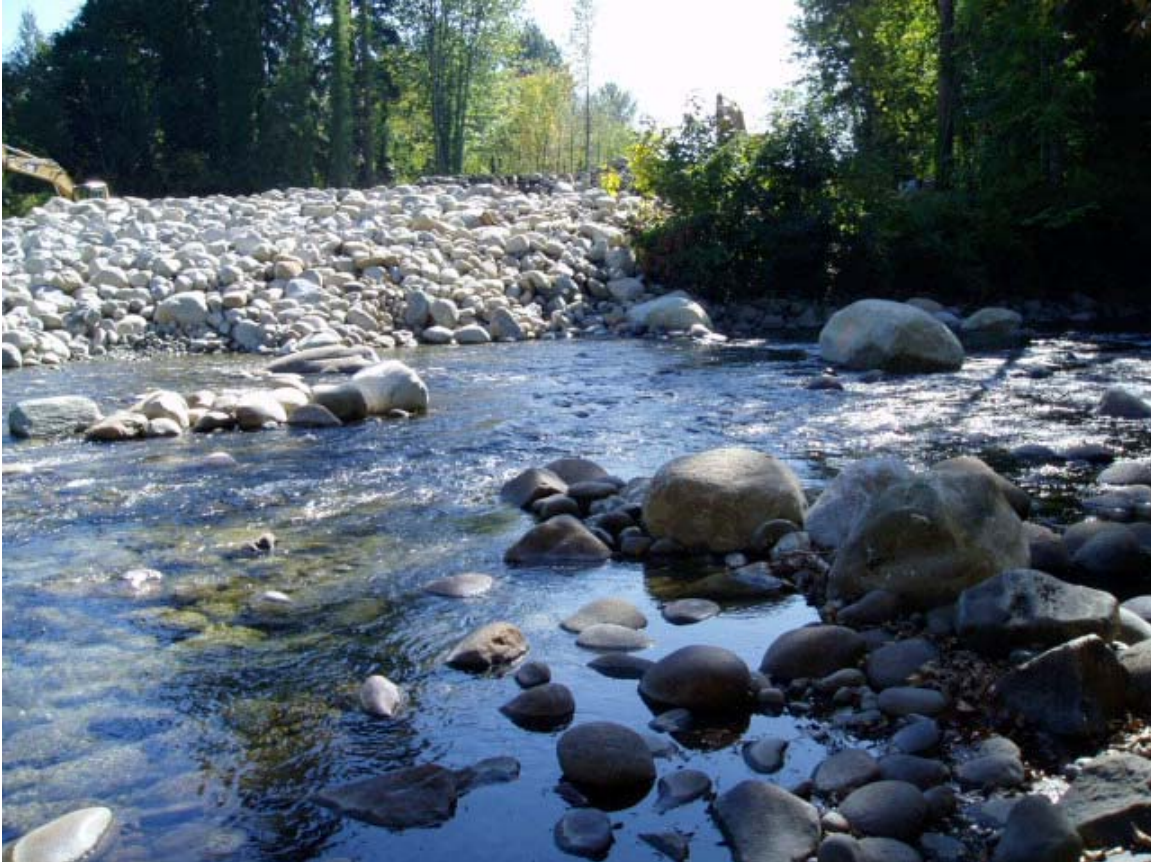
This is the work that was planned and supervised by paddlers. The work was done in a hurry, but there should be some nice eddies, and possibly some waves in this area. The features are constructed with round rock, similar to typical rocks found in the Seymour. Volunteers filled the gaps between the boulders with cobble to any reduce entrapment hazards. **The features should be safe, but please paddle with caution. They could shift during high water events.**

Photo 3 – Boulders installed in September 2006, downstream of water main.

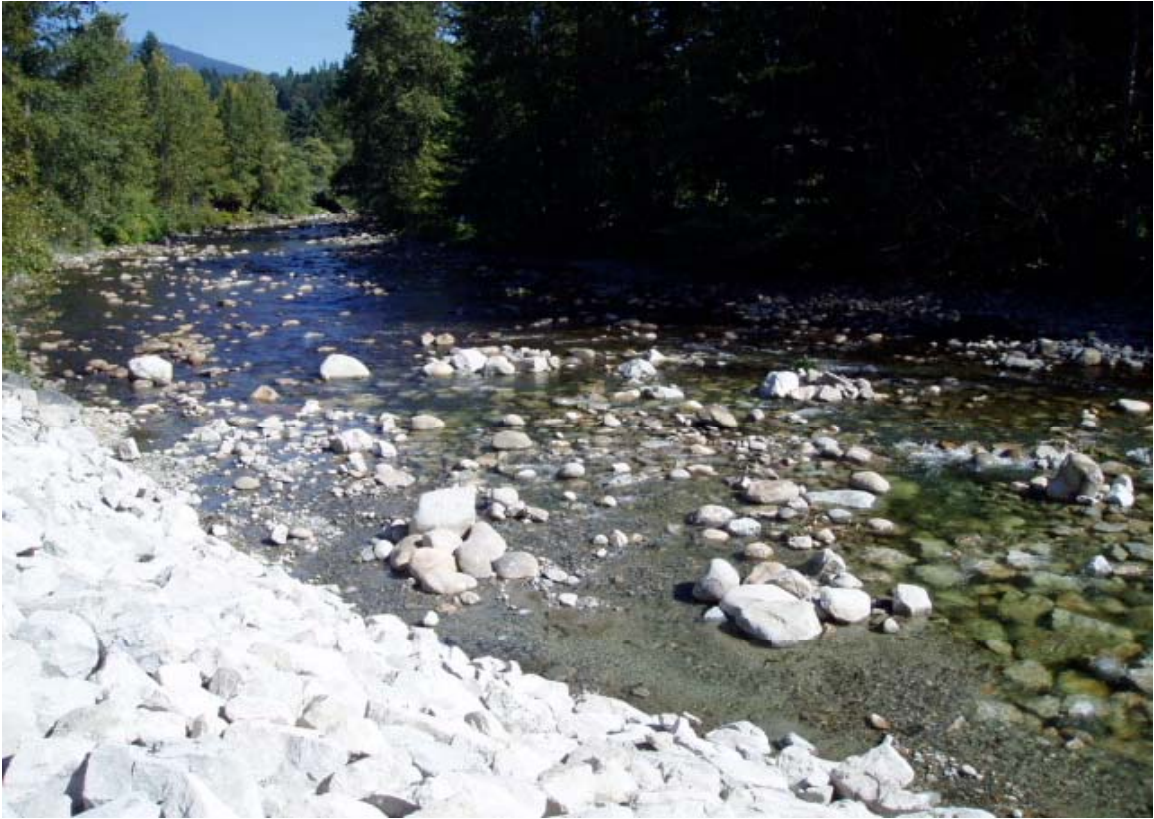
The modified riverbed is typical of the rest of the river run with respect to difficulty, but **there are a few new hazards to be aware of**. These hazards were created by the rip-rap chosen by the GVRD engineers to reconstruct the riverbed in the upstream portion of the work area. Unfortunately I was unable to provide much input, or supervise the work done in this upstream portion of the riverbed reconstruction. Perhaps in the future, something can be done to reduce the hazard, such as distribute some finer cobble and gravel.

- 1) Foot entrapment hazard**
- 2) Features with sharp rock protruding**
- 3) Unstable features that will likely shift with floods.**

As you can see in photo 4 below, when the upstream portion of the riverbed was reconstructed, they created some boulder clusters, depressions and channelization. What you can't see in the photo is how angular the rip-rap is. Some of the boulders have very sharp edges. It is likely that much of it will shift with the floods this winter. Be very cautious of the foot entrapment hazard and the possibility of hitting the sharp edges in or out of your boat.

The upstream reconstruction was unsupervised by paddlers, and unfortunately there was a lack of rounded boulders leftover by the time they got around to doing this portion of the project. On the positive side, once the boulders shift and stabilize, this area should be better for paddling and habitat than the riverbed was before the water main project.

Photo 4 – Contouring of riverbed in upstream portion of work area, September 2006.

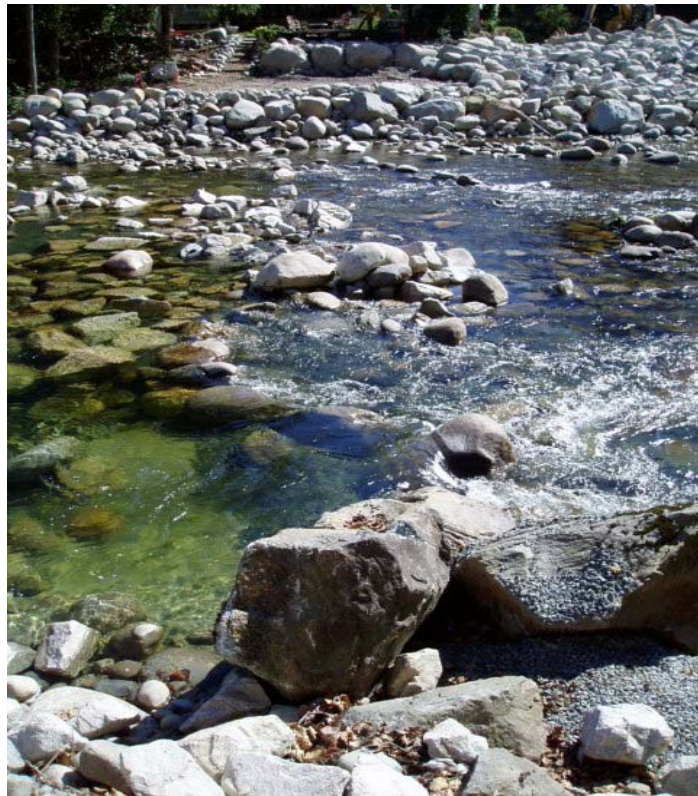
Photo 5 – Pool and contouring at storm drain, river right.
